**An Enquiry**  
into the  
**reasons** for **burning**  
of  
**Coach-6**  
of the  
**Sabarmati Express**

January 2005

Hazards Centre  
New Delhi

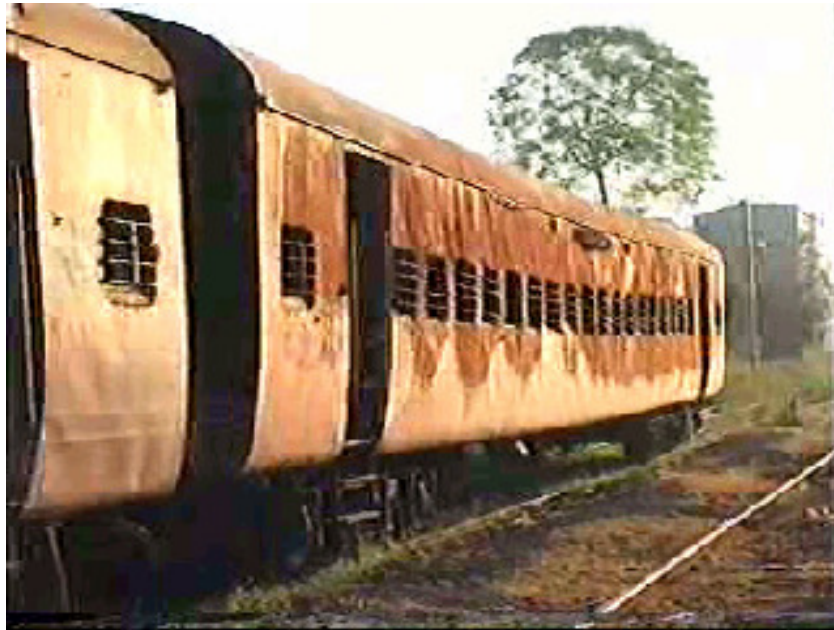
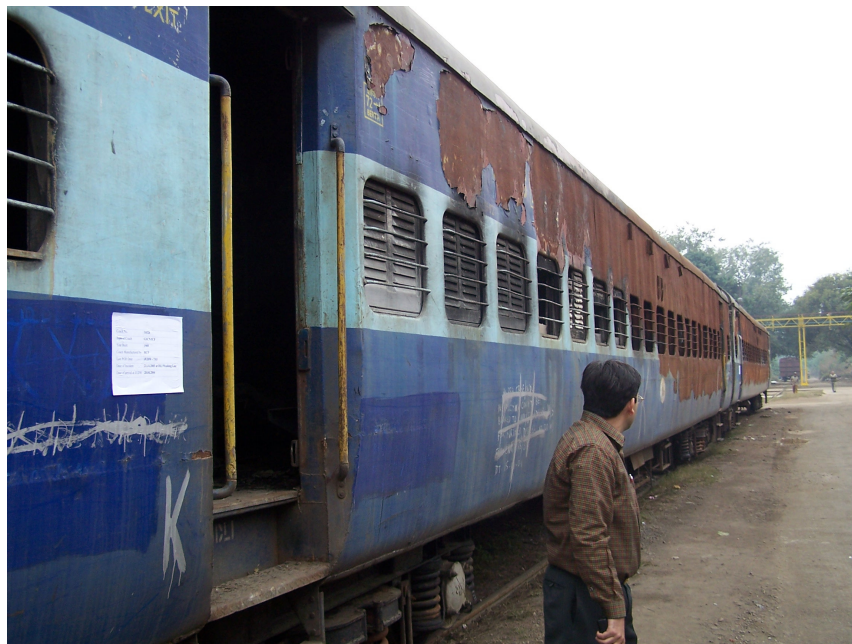
**HEAT MARKS ON THE OUTSIDE OF THE COACH WITH  
PAINT MELTING GREATER ON THE END WHERE FIRE INITIATED**

**GODHRA COACH**

**COACH 16526 BURNT IN DELHI**

1. The heat marks are clearly visible on the sides of both the Delhi and Godhra coaches where the paint has got scorched and peeled or vaporised off. The heat marks on the left and right side of both the coaches are roughly similar and more severe on the upper half of the coaches. The patterns are also very similar, indicating that the heat was greater at one end of the coach in both cases. It should be noted that the Delhi coach was painted blue while the Godhra coach had a red coat. In the case of the Delhi coach it is also known that no materials were thrown from outside.

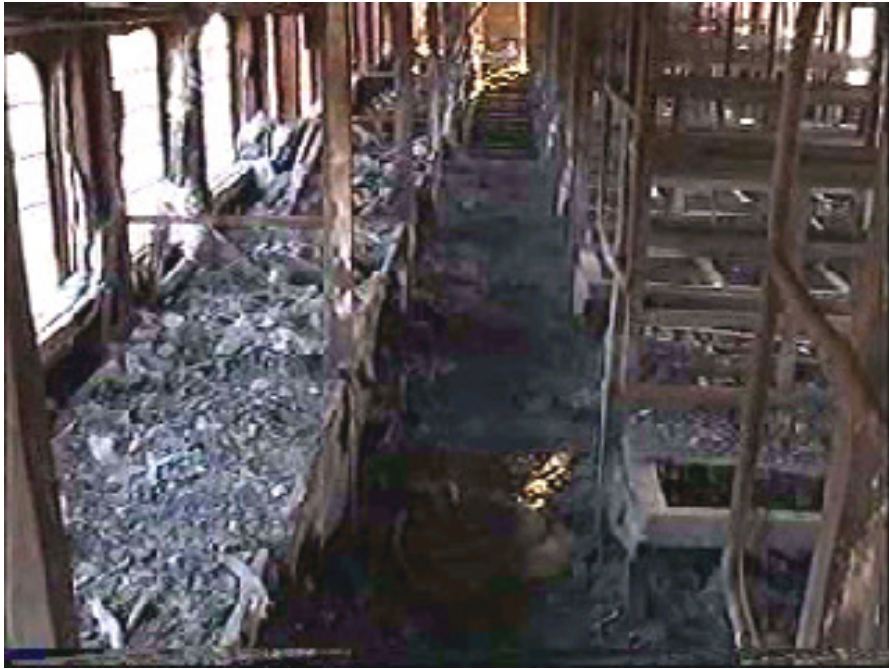
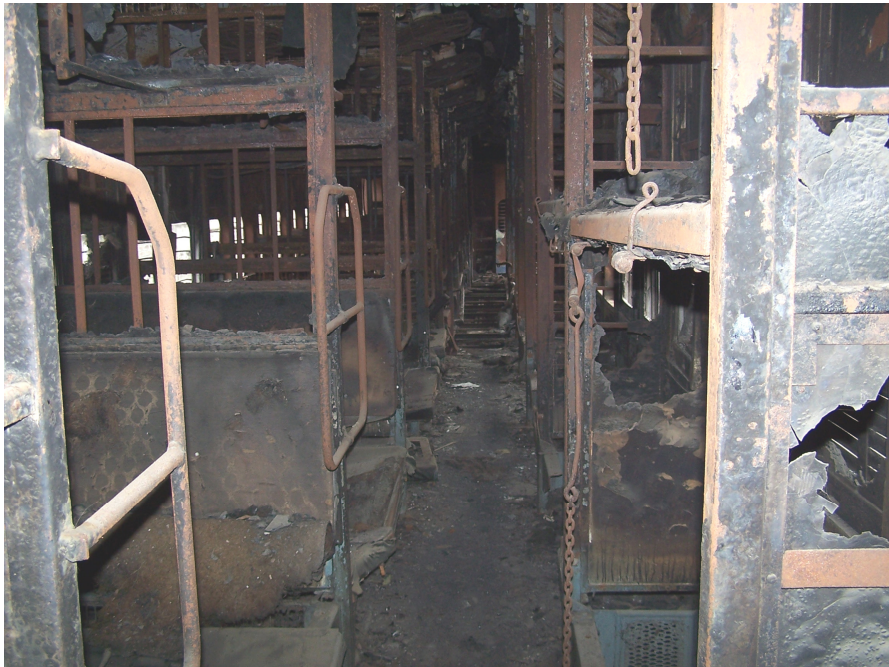
**HALF THE FLOOR LENGTH CRUMBLD ON THE SIDE WHERE FIRE  
STARTED**

**GODHRA COACH**

**COACH 16526 BURNT IN DELHI**

3. The pattern of heat marks on the outside of the coaches is clearly correlated to the conflagration inside. In both the coaches almost half the plywood floor has crumbled in one half where the fire presumably originated, although the under-floor remains intact. The vinyl and foam berths and sunmica partitions have been completely destroyed in this half and the steel is mangled. On the

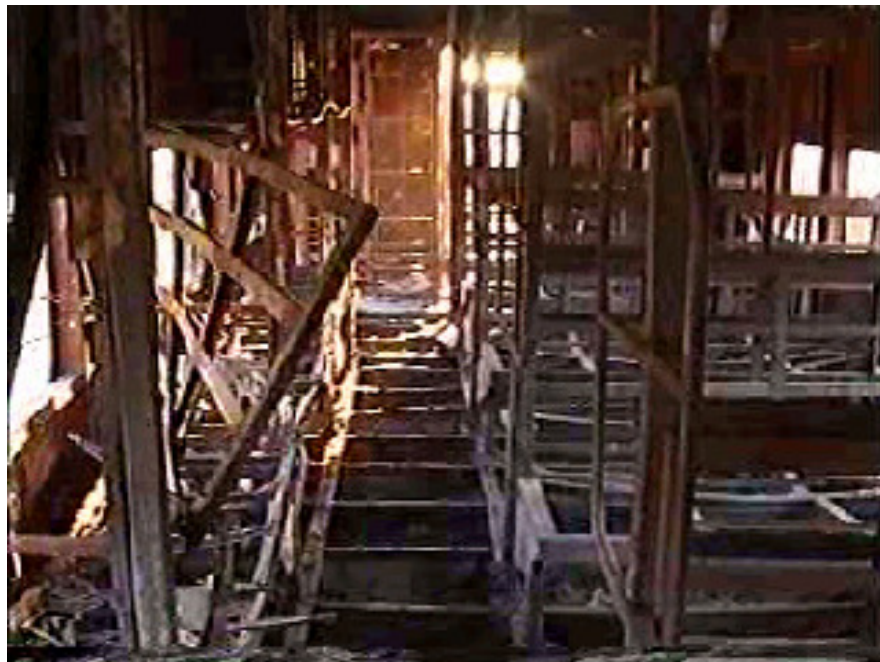
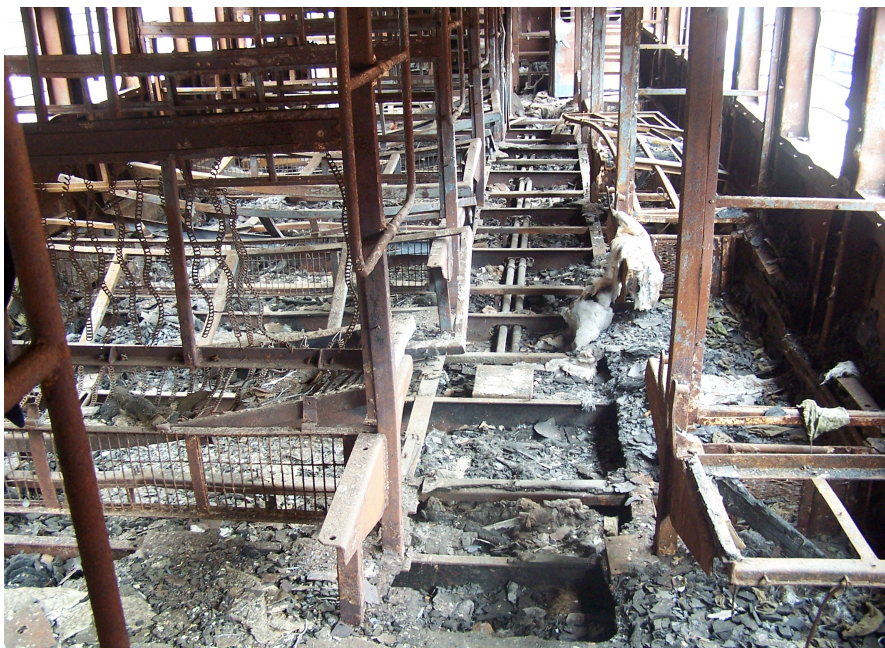
**DETAILS OF THE SIDE WHERE FIRE INITIATED**

**GODHRA COACH**

**COACH 16526 BURNT IN DELHI**

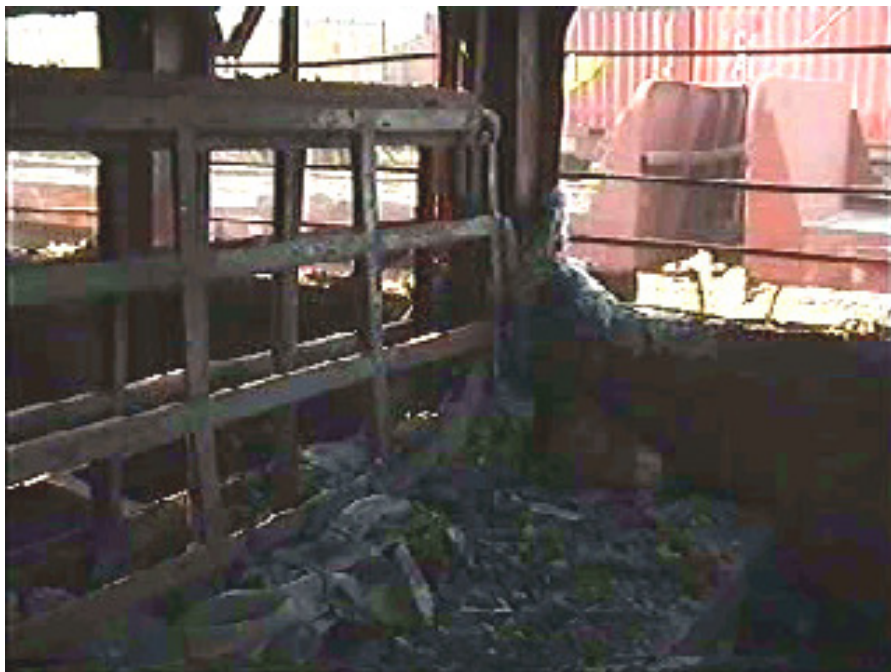
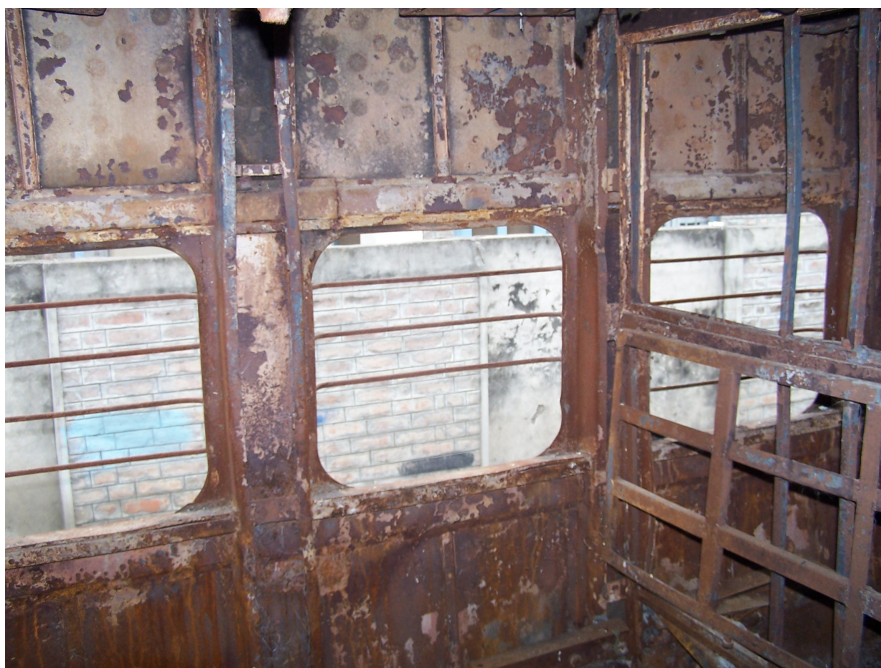
### **SEAT AND WINDOW DETAILS**

**GODHRA COACH**

**COACH 16526 BURNT IN DELHI**

4. The seat and window details in both the coaches are also remarkably similar. The reinforced fibre shutters and glass panes as well as the aluminium frames have vanished on the side the fire originated. As the distance from the centre of the fire increases, the aluminium frames and reinforced fibre shutters slowly begin to reappear, as do scorched remains of the seats.

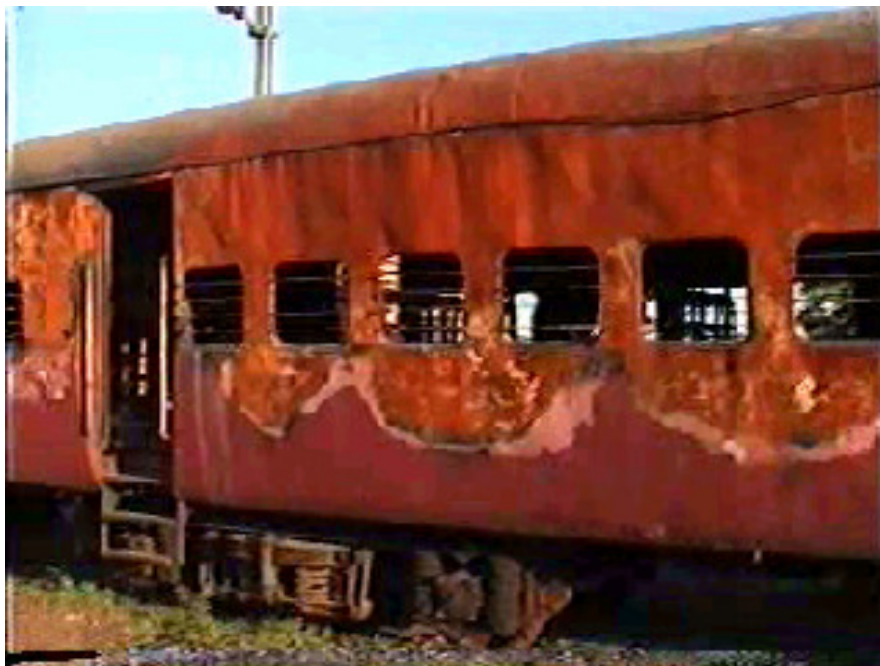
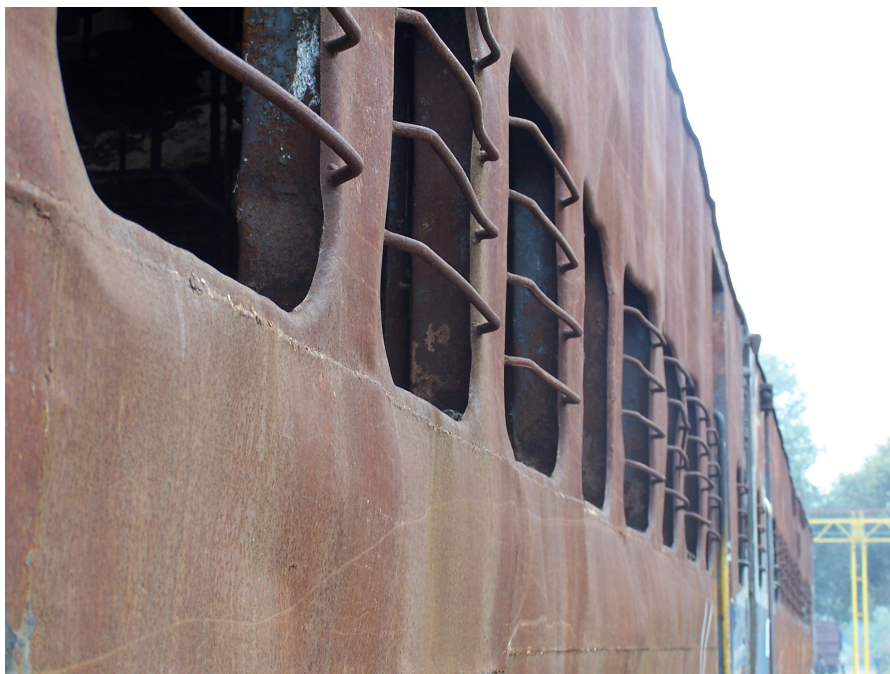
**CRINKLING OF THE BODY**

**GODHRA COACH**

**COACH 16526 BURNT IN DELHI**

2. The crinkling of the steel body and the roof is also similar and has taken place in the middle section but more towards the end where the scorch marks are more pronounced. This crinkling took place as the coach expanded with increasing temperature and the sheet metal folded to take up the structural expansion from one end.

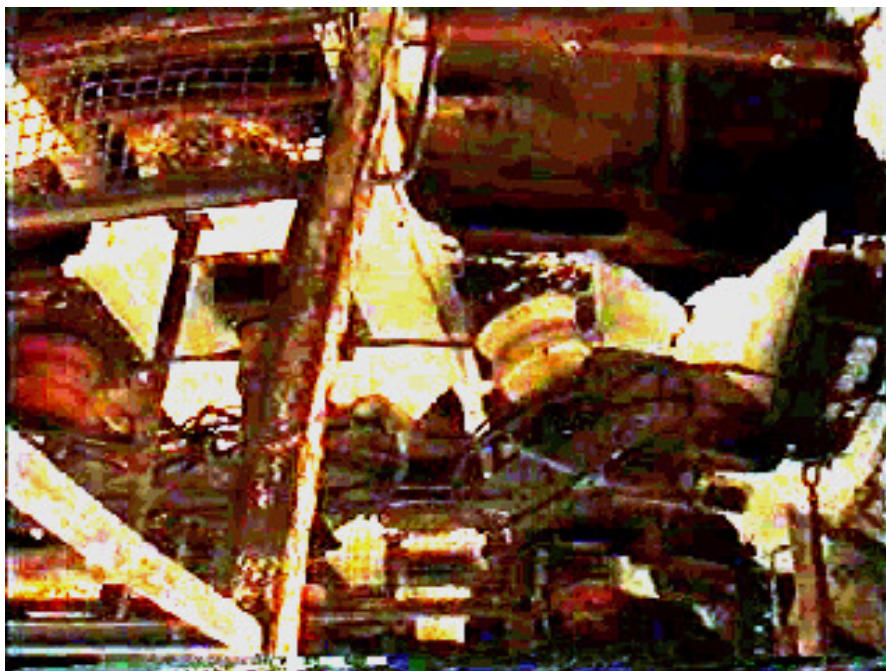
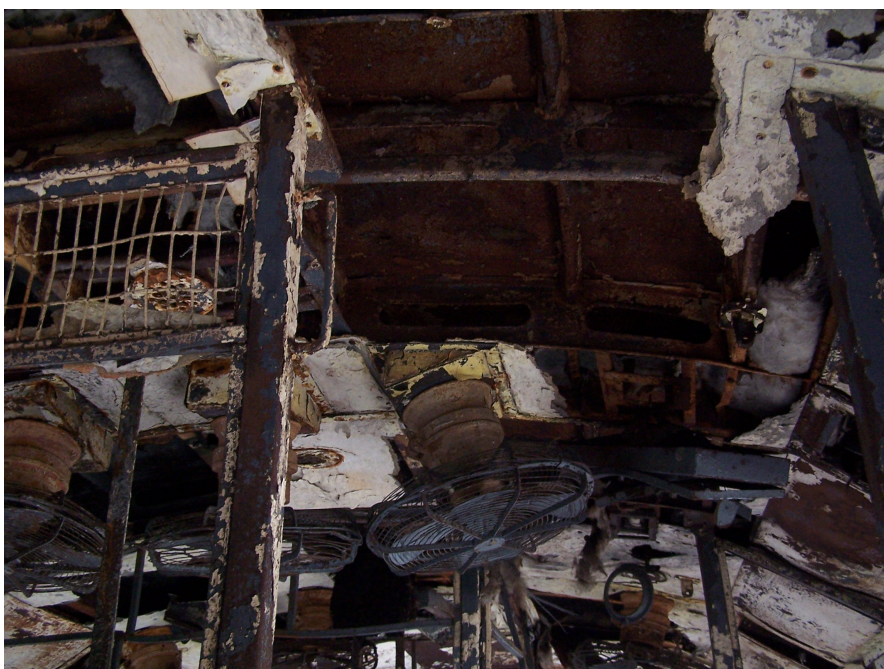
**CEILING DAMAGE**

**GODHRA COACH**

**COACH 16526 BURNT IN DELHI**

5. The damage to the ceilings indicates that in those regions where the highest temperatures obtained, the asbestos ceiling has crumbled, the fan blades have got warped and the underlying synthetic wool insulation has fallen down because of the melting of the bitumen paint, even behind the intact portions of asbestos.

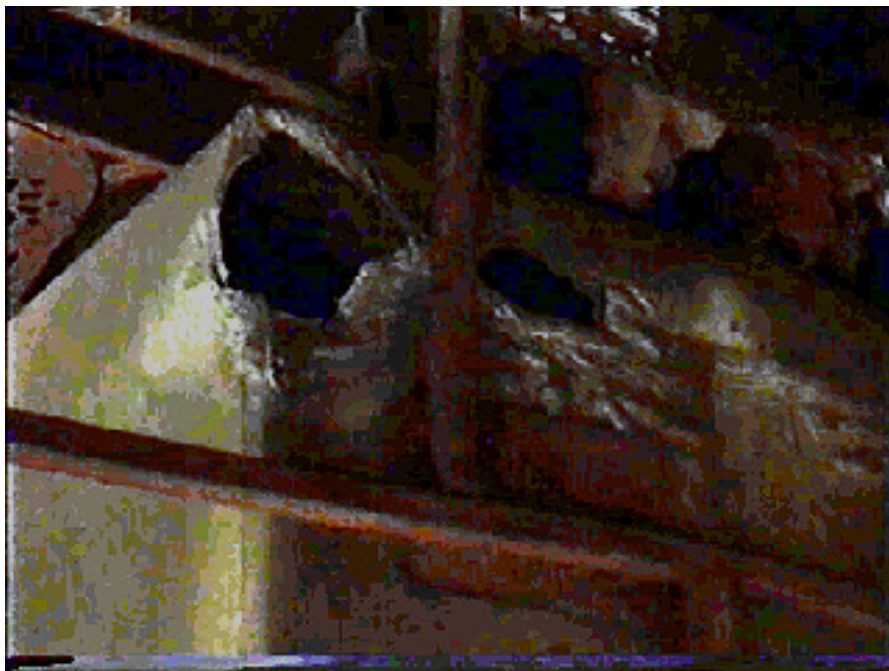
**SPECIFIC FEATURES OF GODHRA COACH**

**GODHRA COACH, WATER TANK FROM THE SEAT 72 END**

6. In the Godhra coach, two important features stand out towards the eastern end, where the floor has also crumpled under the intense heat. Firstly, the aluminium water tank above the luggage compartment next to seats 68-70 displays a large hole towards the inner side indicating that the heat was greatest in the upper portion of this end of the compartment. Secondly, the vestibule near this end also shows burnt patches on the upper side while the lower portion of the rubber seal remains intact.

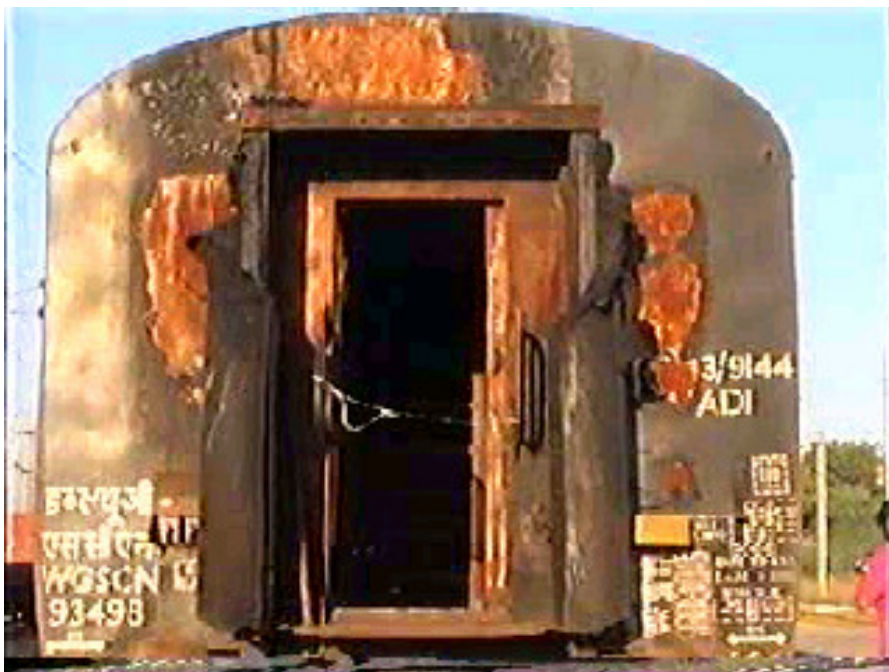
**GODHRA COACH, SEAT 72 END. DAMAGE MARKS SHOW  
FIRE SPREAD TO THE END FROM THE TOP**
